NY Route 144 Complete Streets Study

OPEN HOUSE PUBLIC INFORMATION MEETING

NY ROUTE 144 CORRIDOR VISION

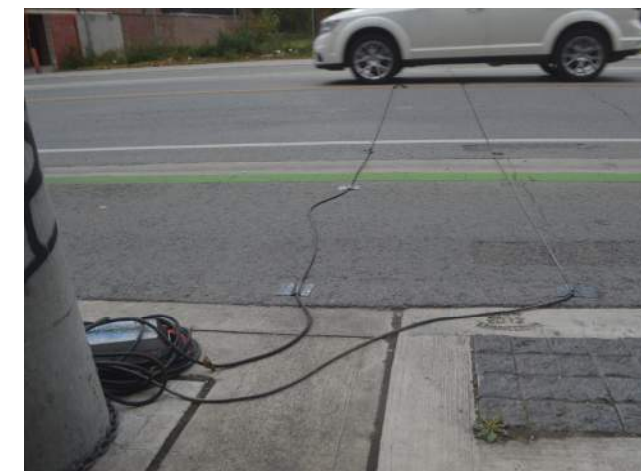
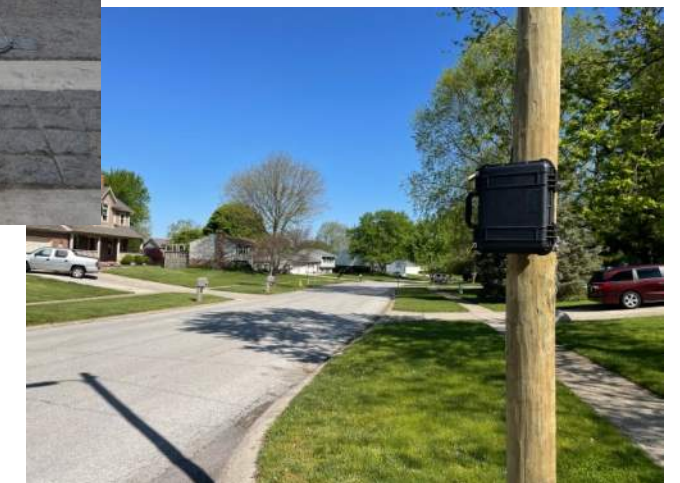
Examples of ATRs, traffic counting tubes and a radar box.

Traffic Data for NY Route 144 was obtained utilizing Automatic Traffic Recorders (ATR) at three (3) locations from July 23rd to July 30th, 2024. Vehicle volume, type and speed.

Summary of Traffic Data within the Study Area

ATR Location	Average Annual Daily Traffic (AADT)	Truck Percentage	Average Speed (mph)	85 th Percentile Speed (mph)
Location 1	1,197	9.5%	40	44
Location 2	1,245	9.2%	34	38
Location 3	887	9.2%	37	41

- The percentage of trucks recorded was found to be higher than the average of 4.7% for similar facilities as defined by the NYSDOT.
- Posted speed limit is 35mph between Gill Rd and Nodine Mtn Rd, 45mph elsewhere.
- The 85th percentile speed is defined as that speed at or below which 85% of all vehicles are observed to travel.

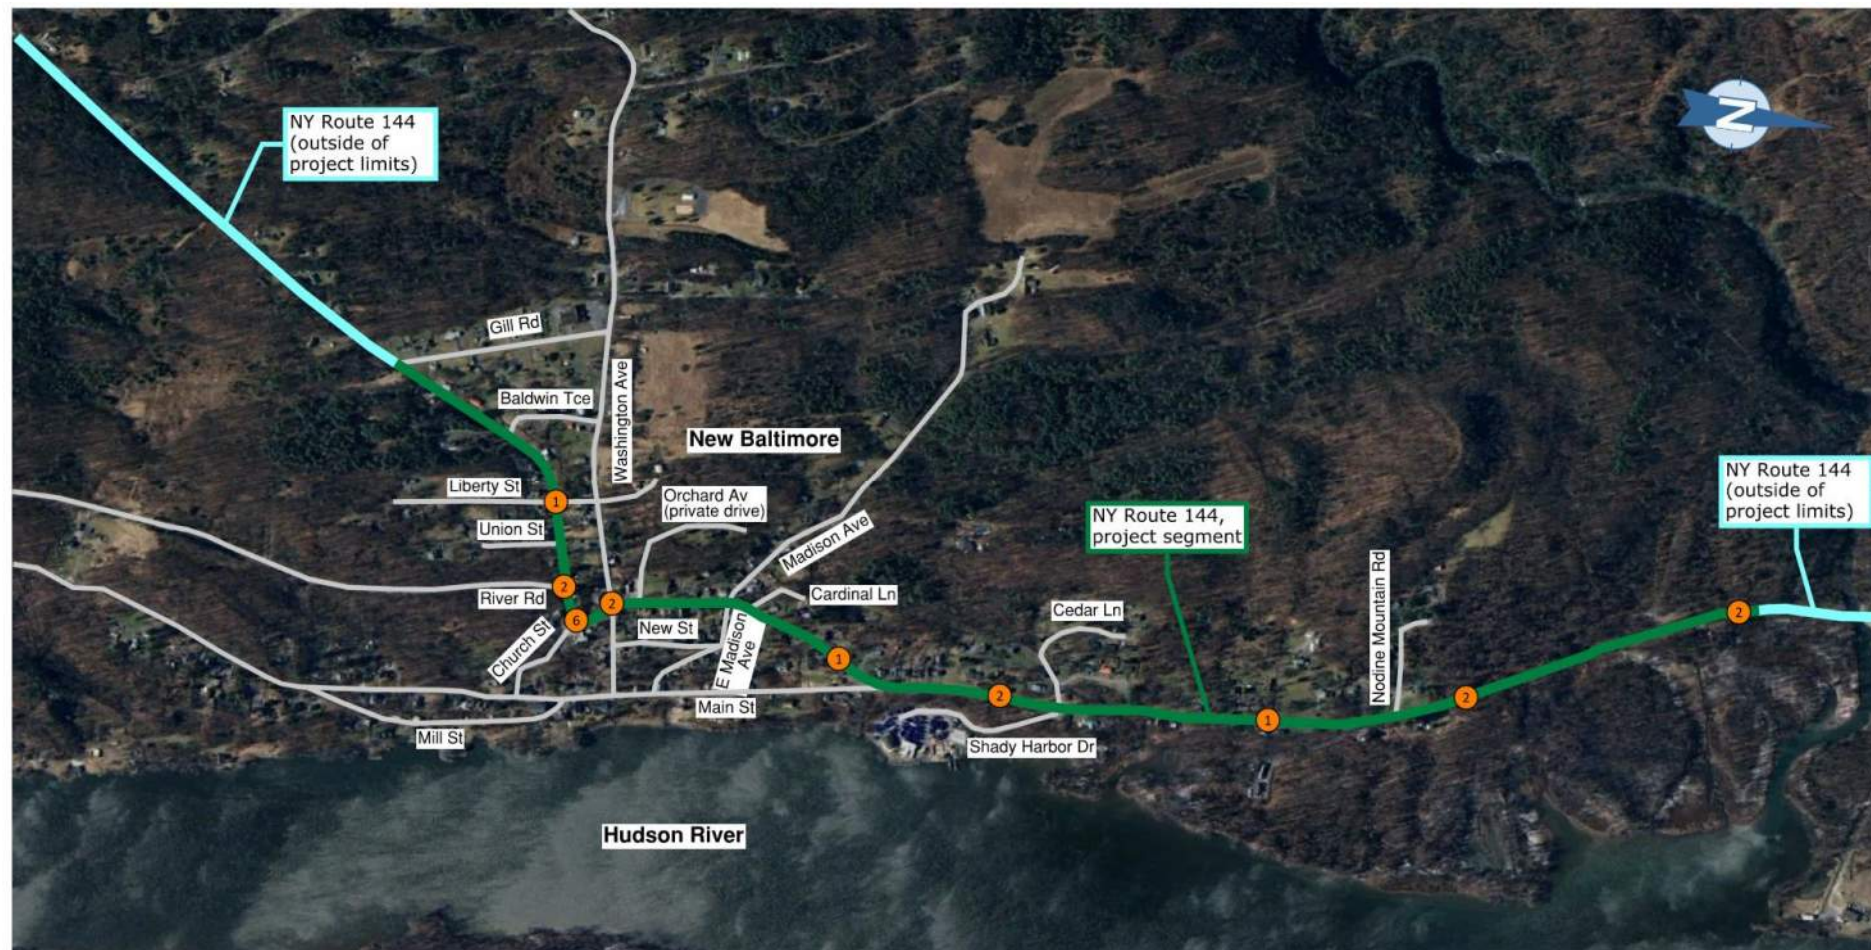
CRASH HISTORY

NYSDOT CLEAR Crash Data Viewer was used to obtain the most recent five years of data (12/31/2018 – 12/31/2023) for NY Route 144. Of the 19 total crashes, 0 involved pedestrians/bicyclists and 0 involved a fatality.

6 of 19 total crashes occurred at the intersection with Church Street (31.6% of the crashes). All but one of the crashes occurring at this intersection were described as failure to navigate the sharp curve at this intersection or a failure to keep right in the curve.

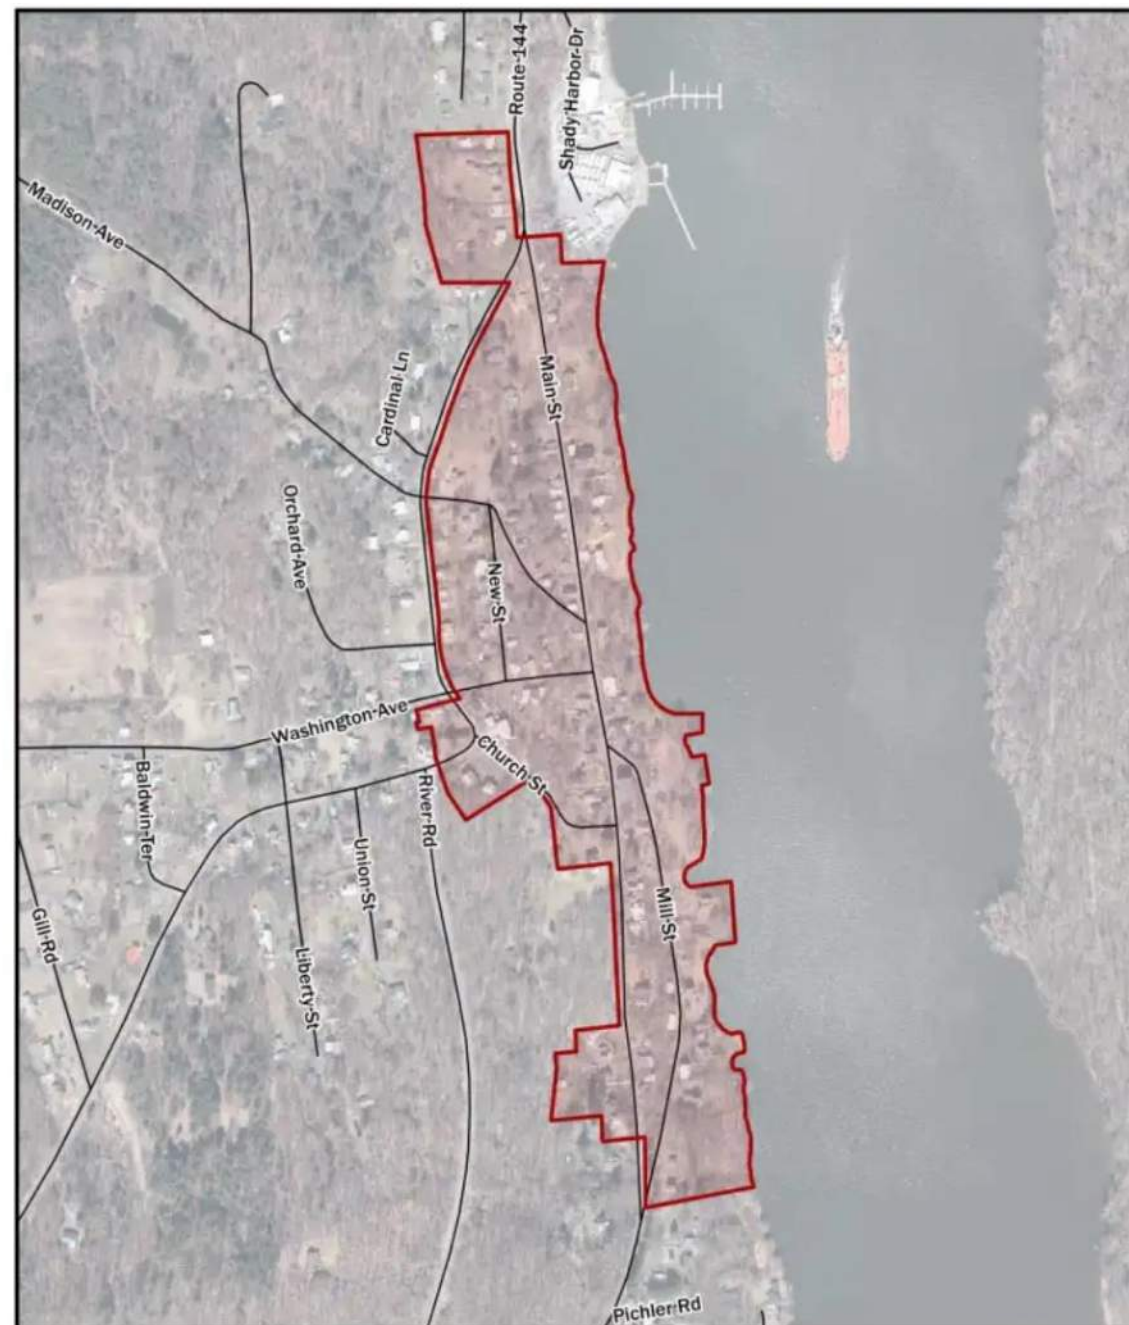
Nomination Boundary

The New Baltimore Hamlet Historic District is located within the study area. The New Baltimore Hamlet Historic District is located on Main Street and adjacent streets and is comprised of 89 buildings listed on the National Register of Historic Places.

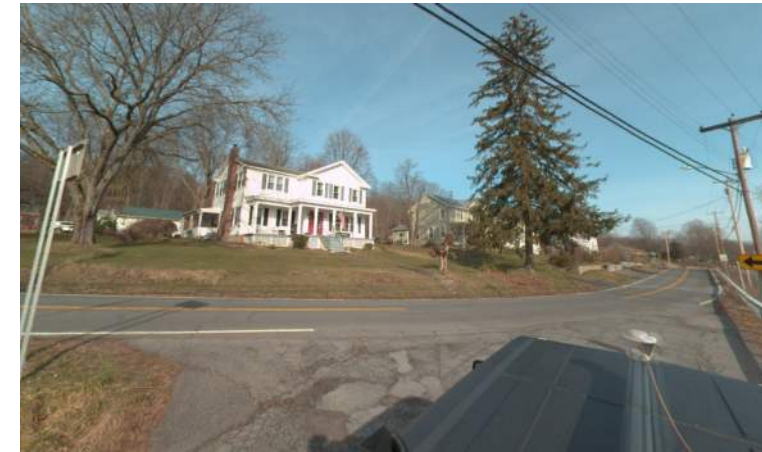
- Intersection with Main Street has poor sight distance due to roadway geometry, and motorists need to look over their shoulders to enter NY 144 from Main Street
- Intersection with Washington Avenue (east) has poor sight distance for motorists entering NY Route 144 due to the proximity of buildings to NY Route 144 at the intersection

View of motorist
"looking ahead" from
Main Street to NY
Route 144

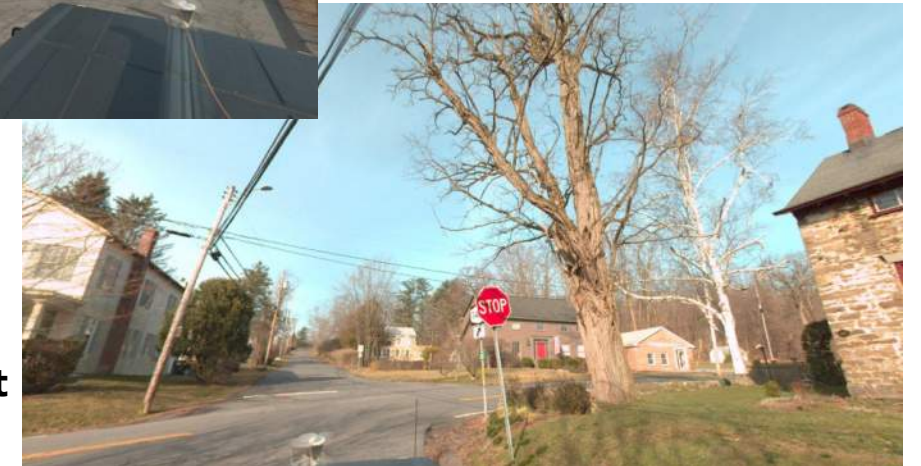
Building and trees
blocking view of
southbound traffic at
Washington Avenue

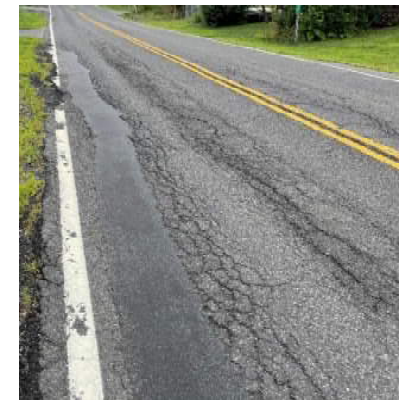
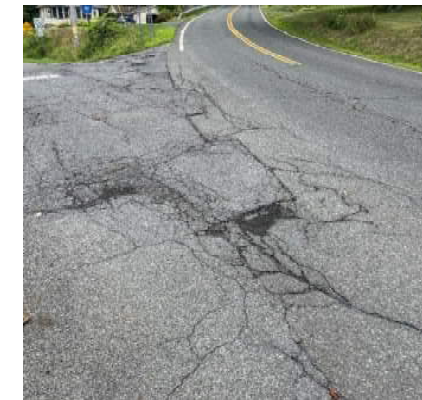
Deteriorating Pavement Conditions

- Pavement shows signs of wear with edge cracking and alligator cracking along the northbound lane
- Steep slopes adjacent to northbound lane in many areas cause pavement settling

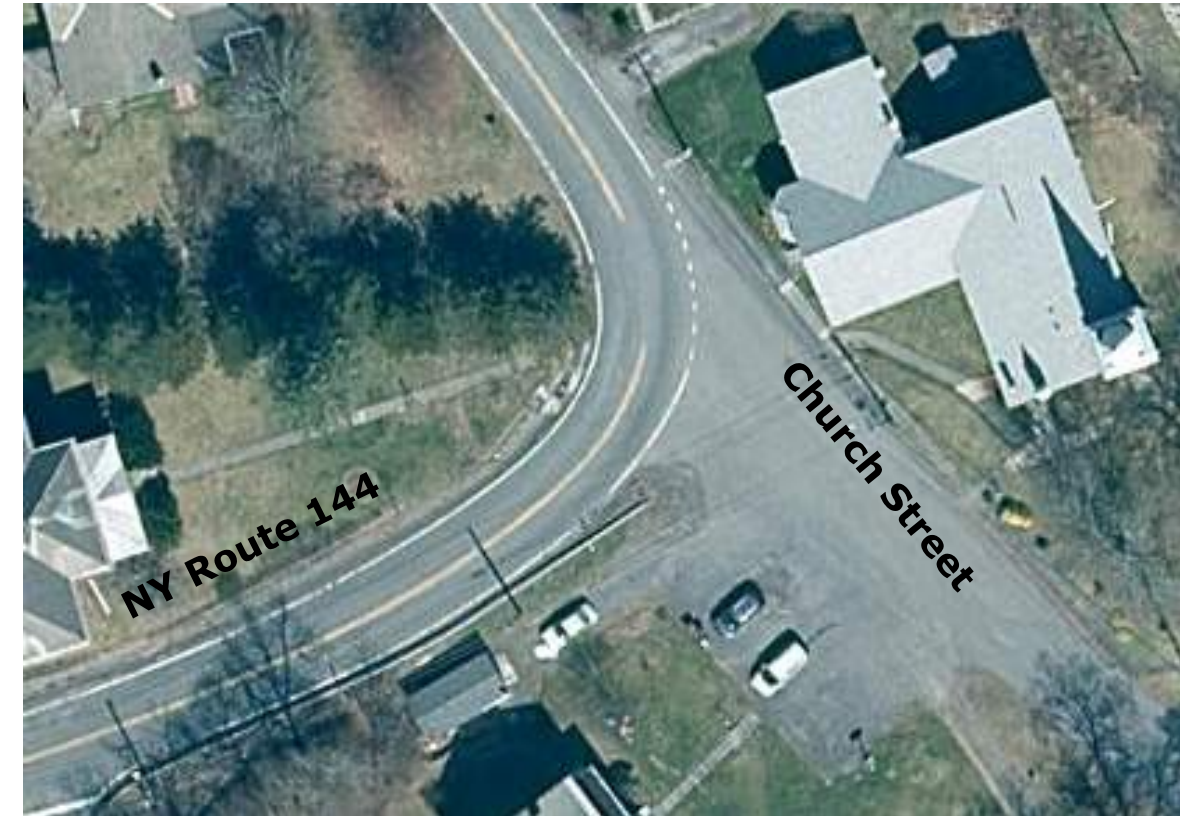
Curve at intersection with Church Street

- Existing curve on NY Route 144 has radius of approximately 50'-0"
- This radius is sub-standard
- The curve is often too tight for oversized vehicles, causing them to undergo awkward maneuvers, endangering pedestrian safety, and causing traffic delays
- Lack of existing advance curve warning and speed reduction signage
- Crash history cluster found at this intersection

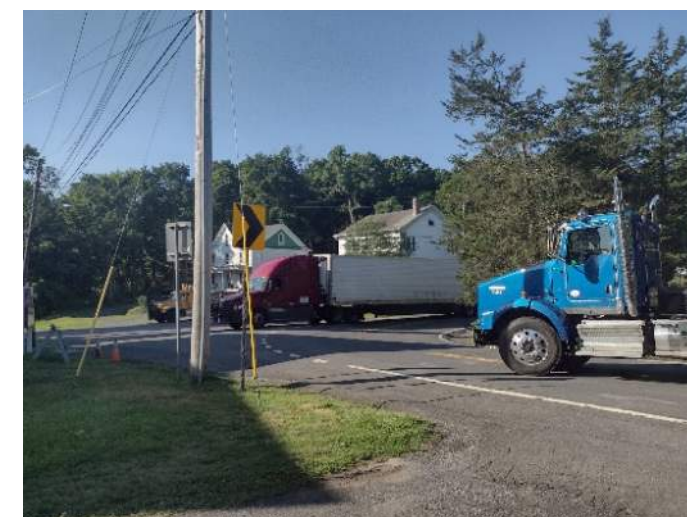
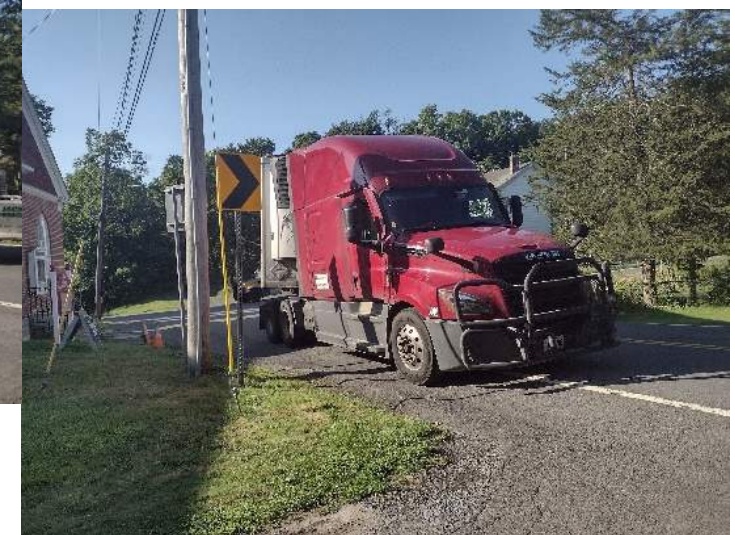
Oversized Trucks & Freight

- The segment of NY Route 144 within the study limits, is not designated as an access highway
- For oversize vehicles to travel along NY Route 144 through the Town of New Baltimore require special permits and police escort, however many oversized vehicles do not currently follow this process
- Insufficient capacity for, and clarity of enforcement responsibility and requirements

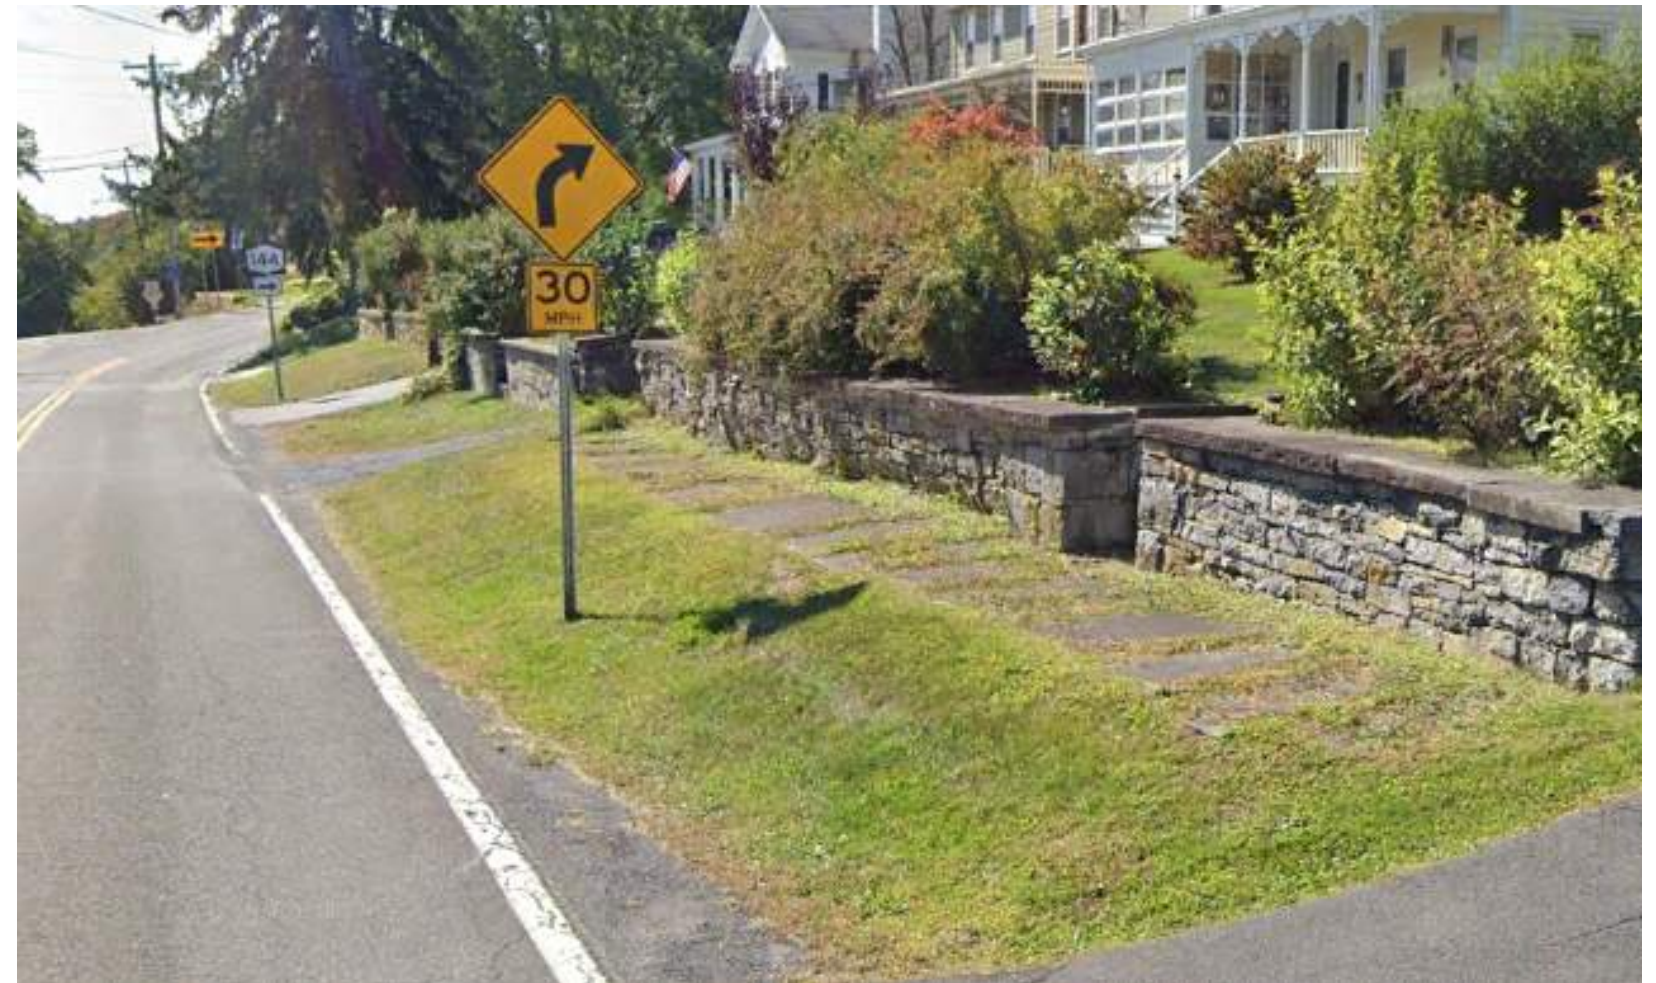
Lack of Sidewalks

- There is a single 65-foot segment of bluestone sidewalk on the west side of NY Route 144 that is not ADA compliant
- No other existing sidewalks are present along NY Route 144
- Lack of sidewalk facilities mean disconnect between residential areas and town center
- Those visiting trailhead at northern project limits are not connected to the historic properties located in the town center
- Safer pedestrian crossing of NY Route 144 from the Hannacroix Creek Preserve parking lot to the Hudson River Interpretive Trail is needed

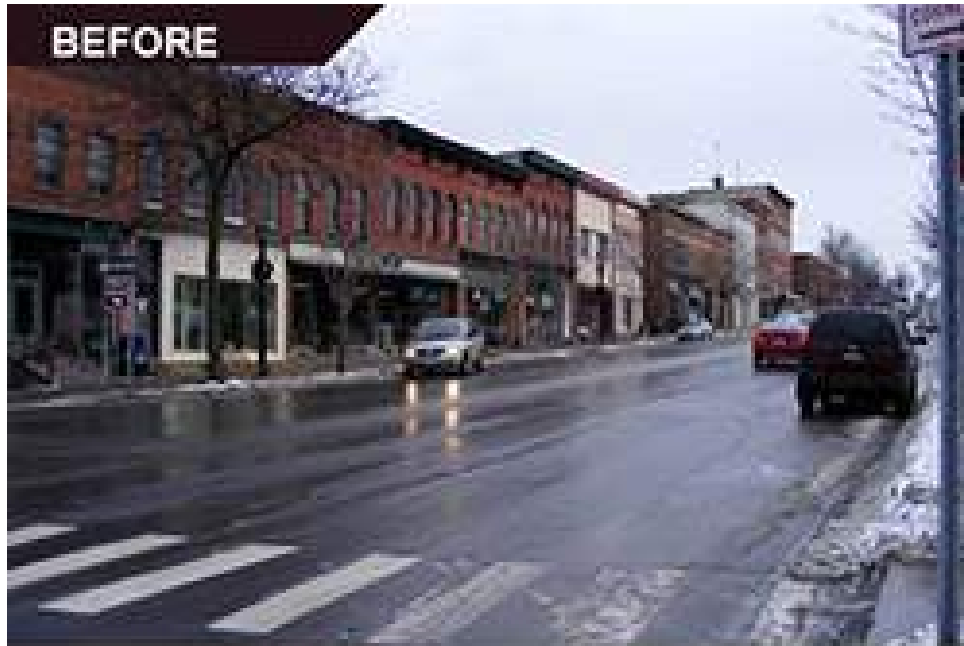
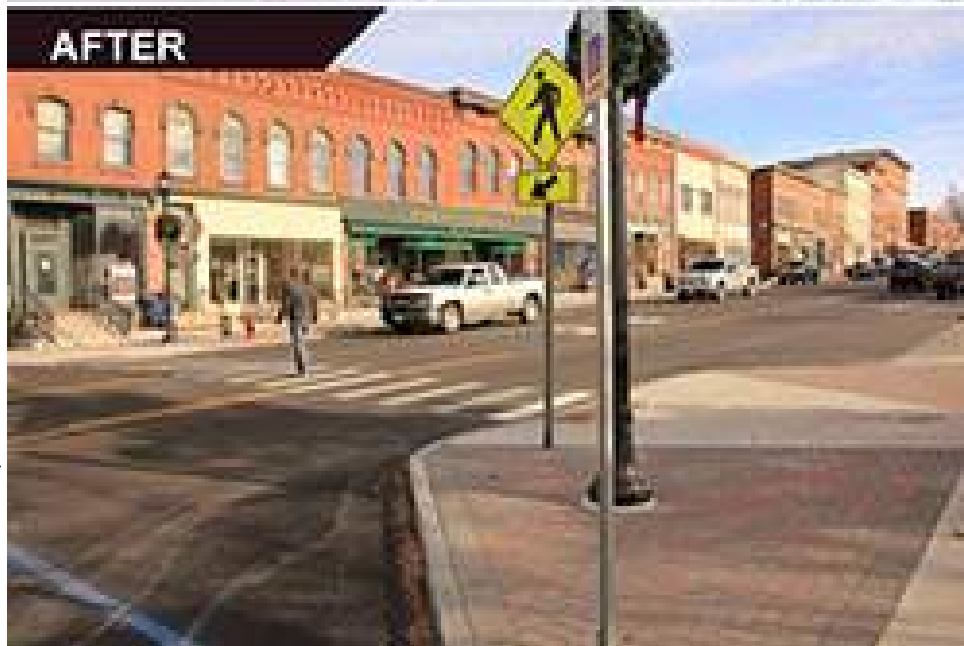
Route 11, Canton

BEFORE

AFTER

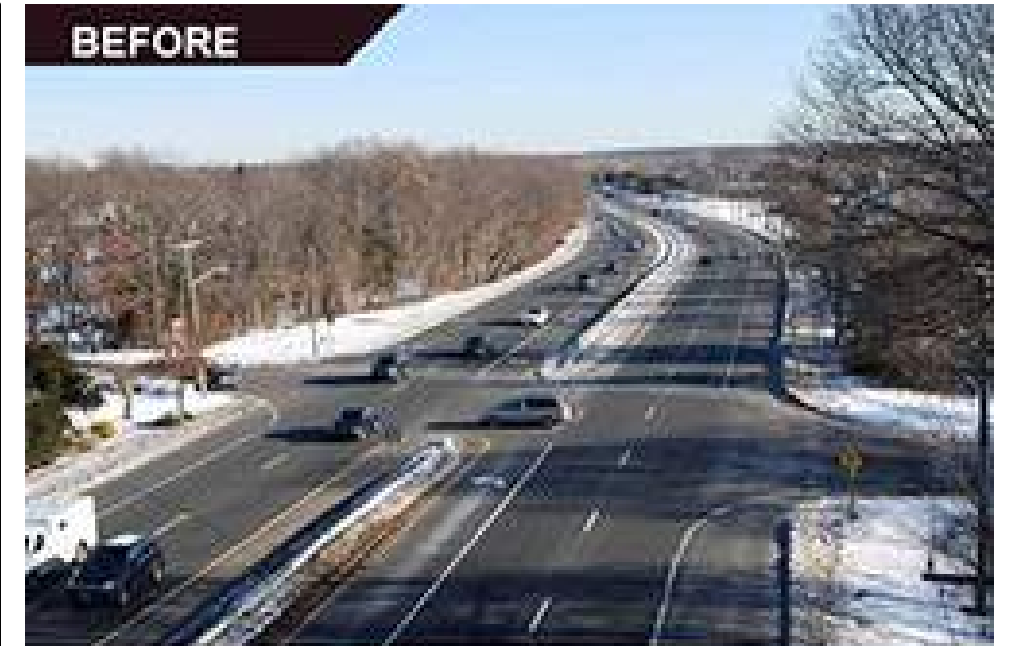
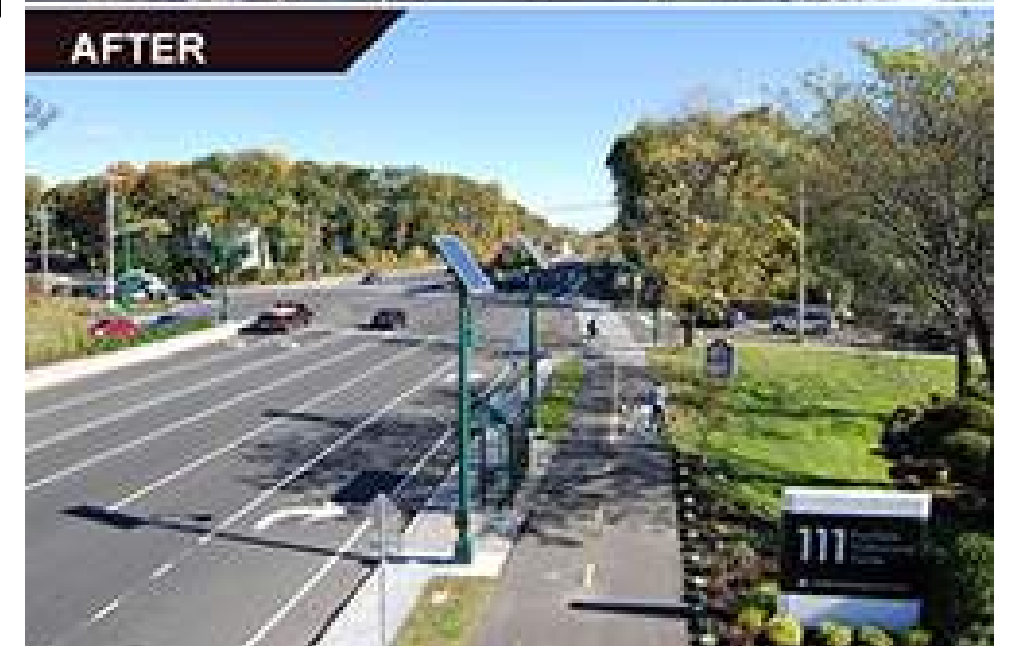
Route 347, Port Jefferson

BEFORE

AFTER

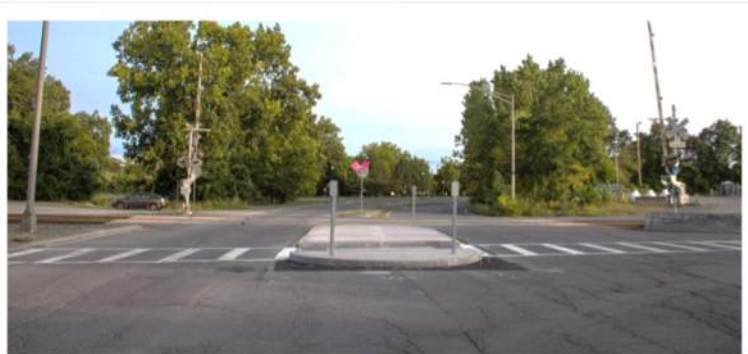
crosswalks & median refuges

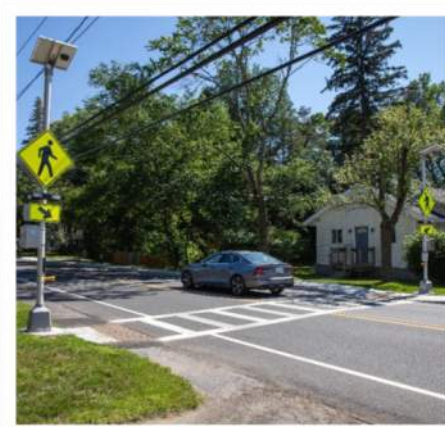
pedestrian signals

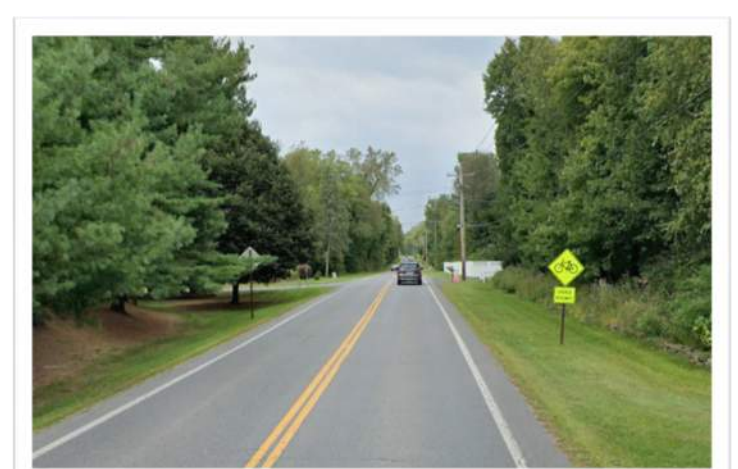
"share the road" signs

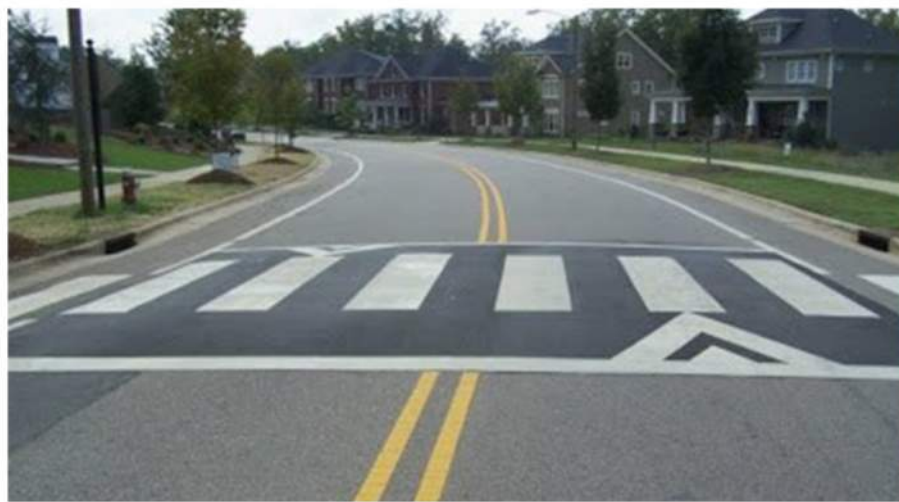
raised crosswalks & ramps

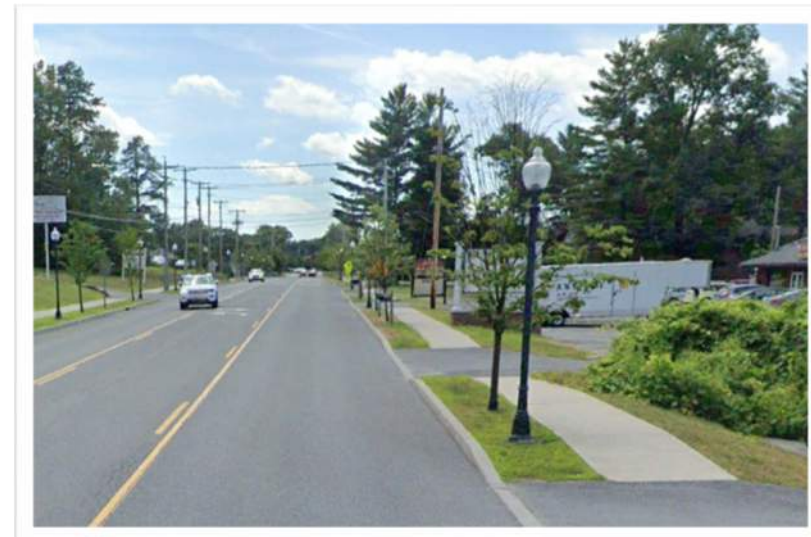
street & sidewalk lighting
