Town of New Baltimore
NYS Route 144 Complete Streets Study

Public Meeting #1

Existing Conditions Overview

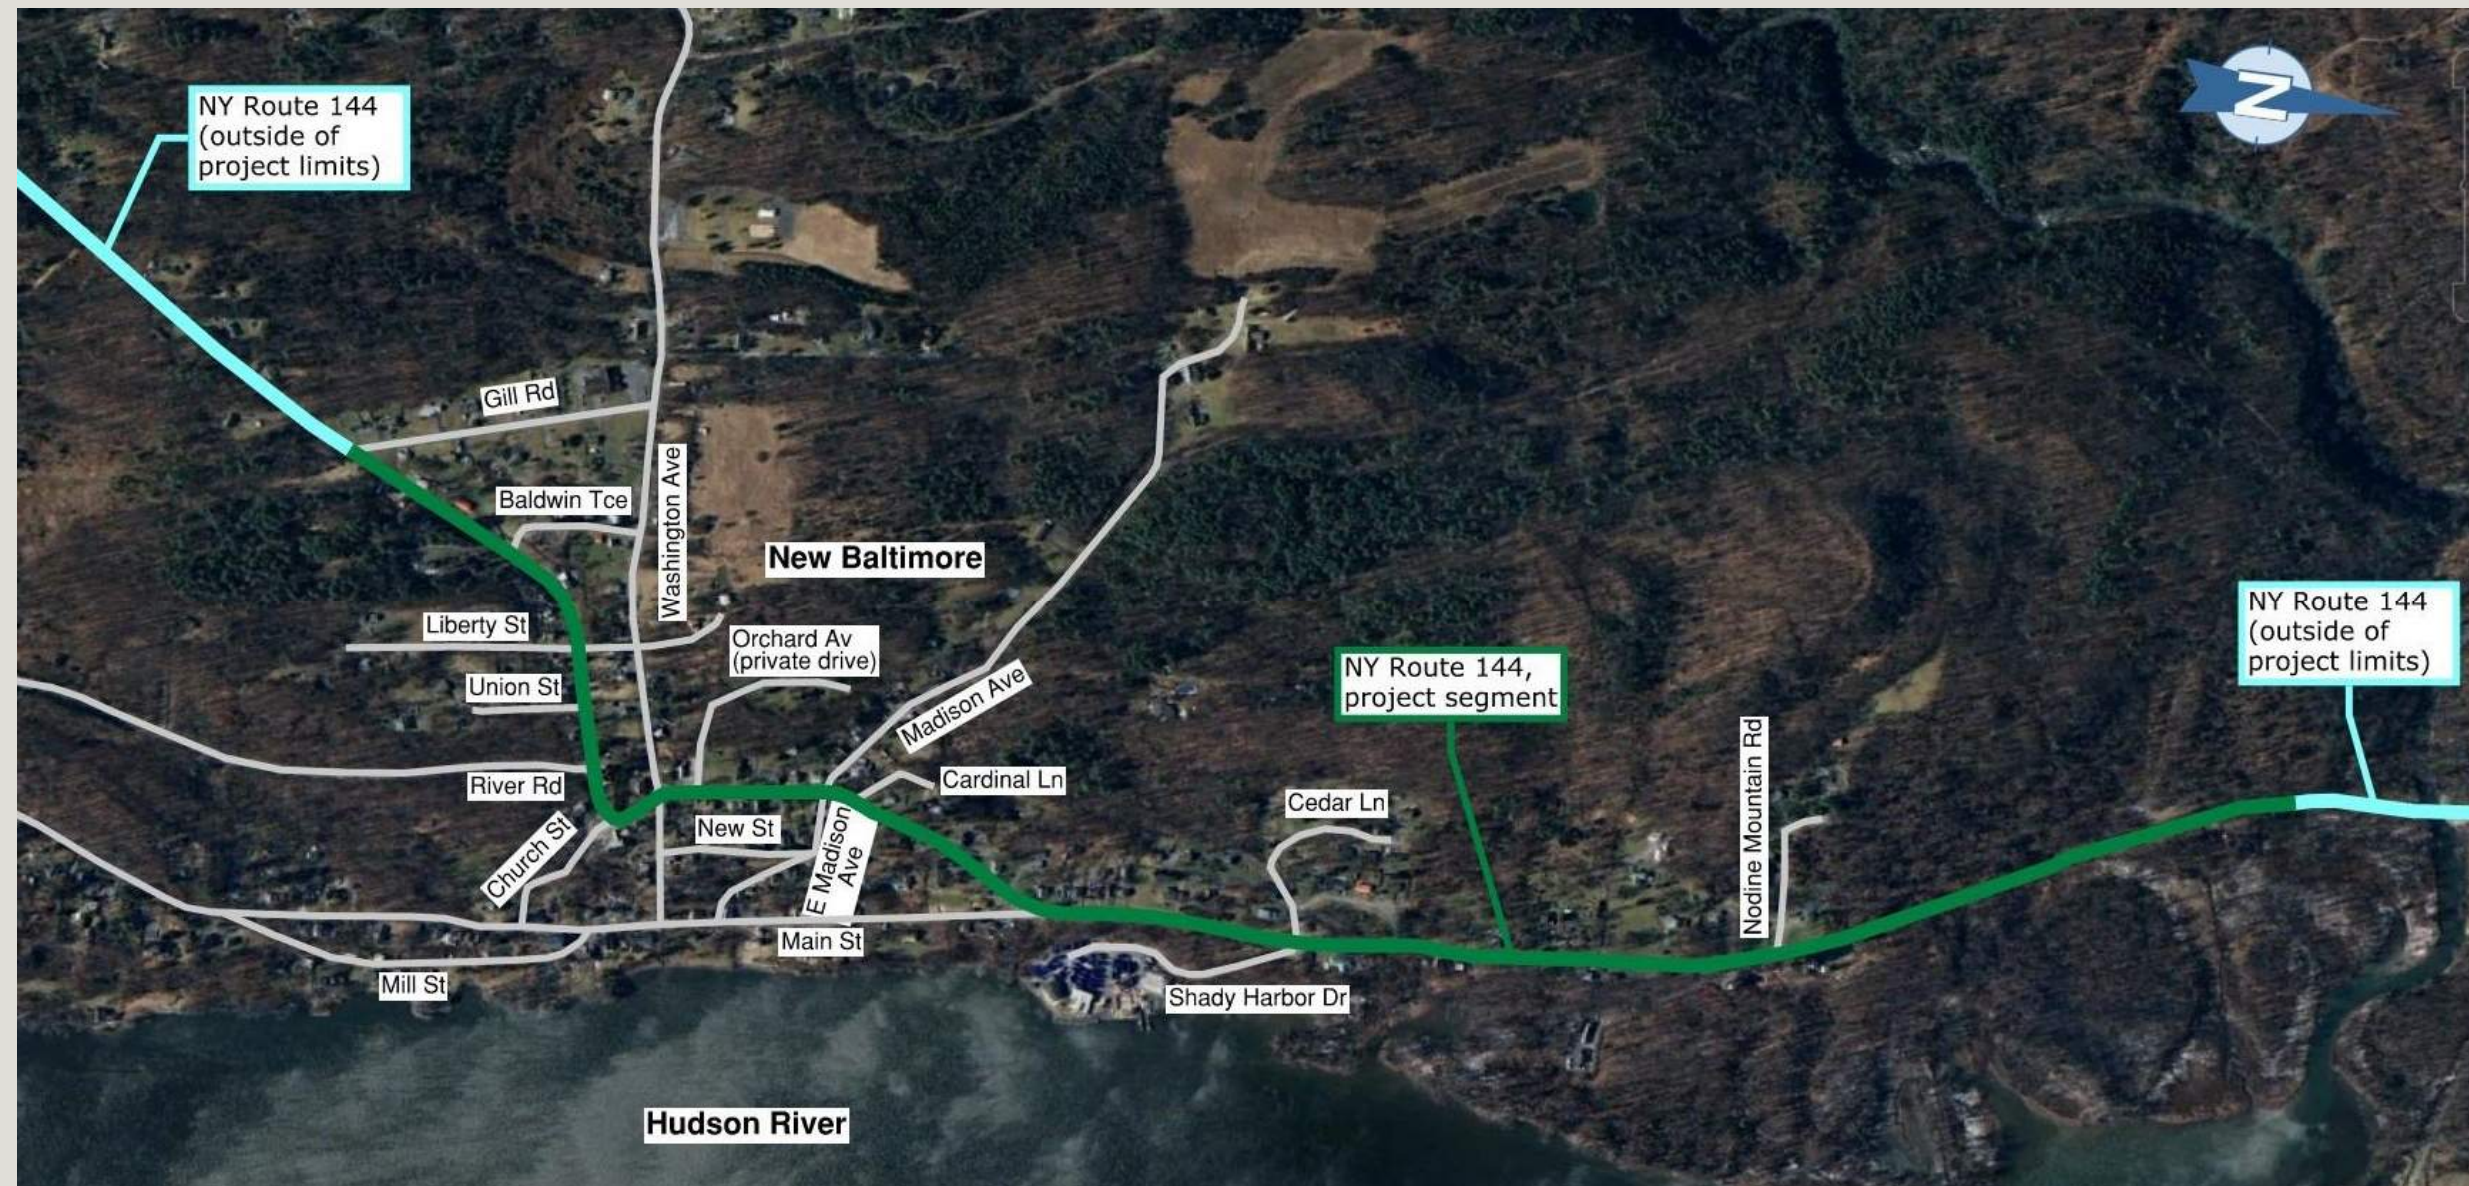
Introduction/Background

- The Study Area includes a 1.65-mile segment of NY Route 144, between Gill Road and the Town border at the Greene-Albany County line

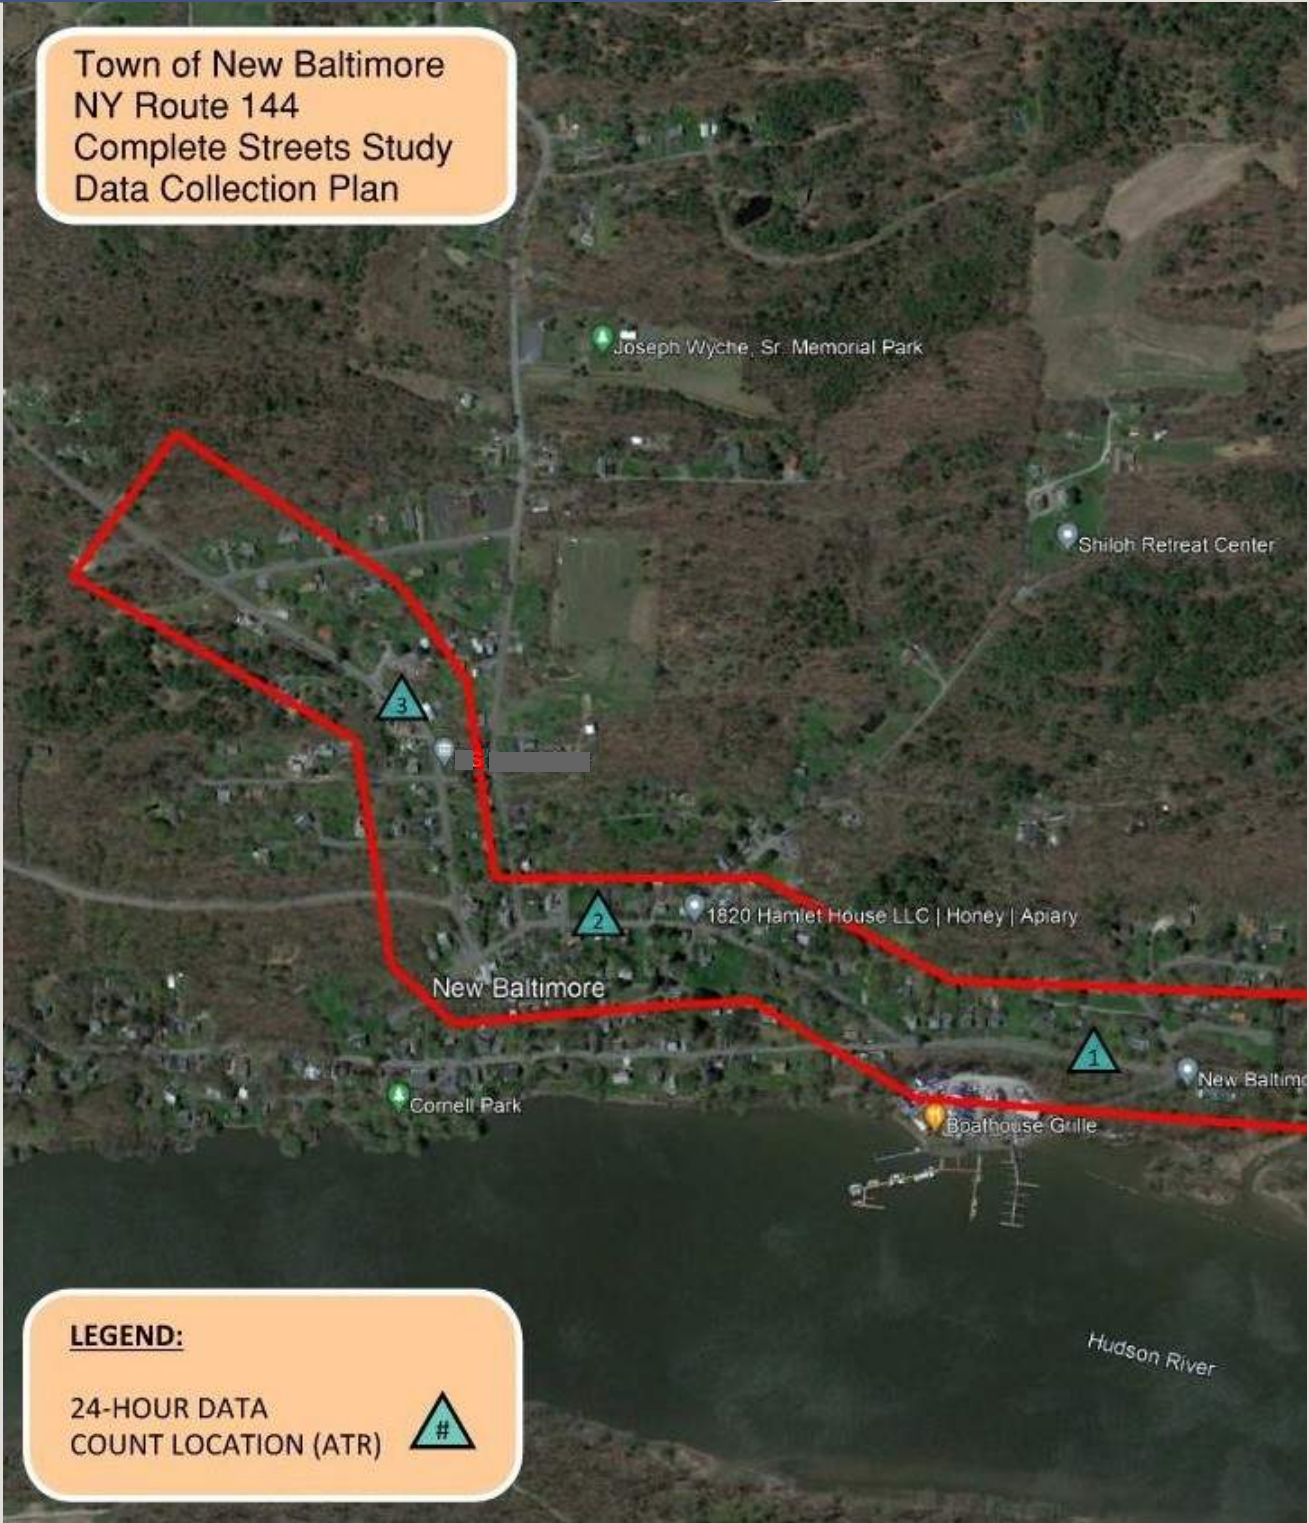
Traffic Volumes and Speed

- Traffic volumes and speed were collected using Automatic Traffic Recorders (ATRs)
- ATRs collected 7 days of data at three locations
 - Tuesday July 23 to Tuesday July 30, 2024
 - Traffic Volume, Speed and Classification
- Posted speed limit is 35mph between Gill Rd and Nodine Mtn Rd, 45mph elsewhere.

Summary of Traffic Data within the Study Area				
ATR Location	Average Annual Daily Traffic (AADT)	Truck Percentage	Average Speed (mph)	85 th Percentile Speed (mph)
Location 1	1,197	9.5%	40	44
Location 2	1,245	9.2%	34	38
Location 3	887	9.2%	37	41

- Recorded heavy truck volume (9.2% to 9.5%) was found to be higher than the average (4.7%) for similar state roadways
- The segment of NY 144 within the study limits is not designated by NYSDOT as an access or qualifying highway
- Oversize vehicles require special permits and police escort, process is often unregulated.
- Insufficient capacity for, and clarity of, enforcement responsibility and requirements

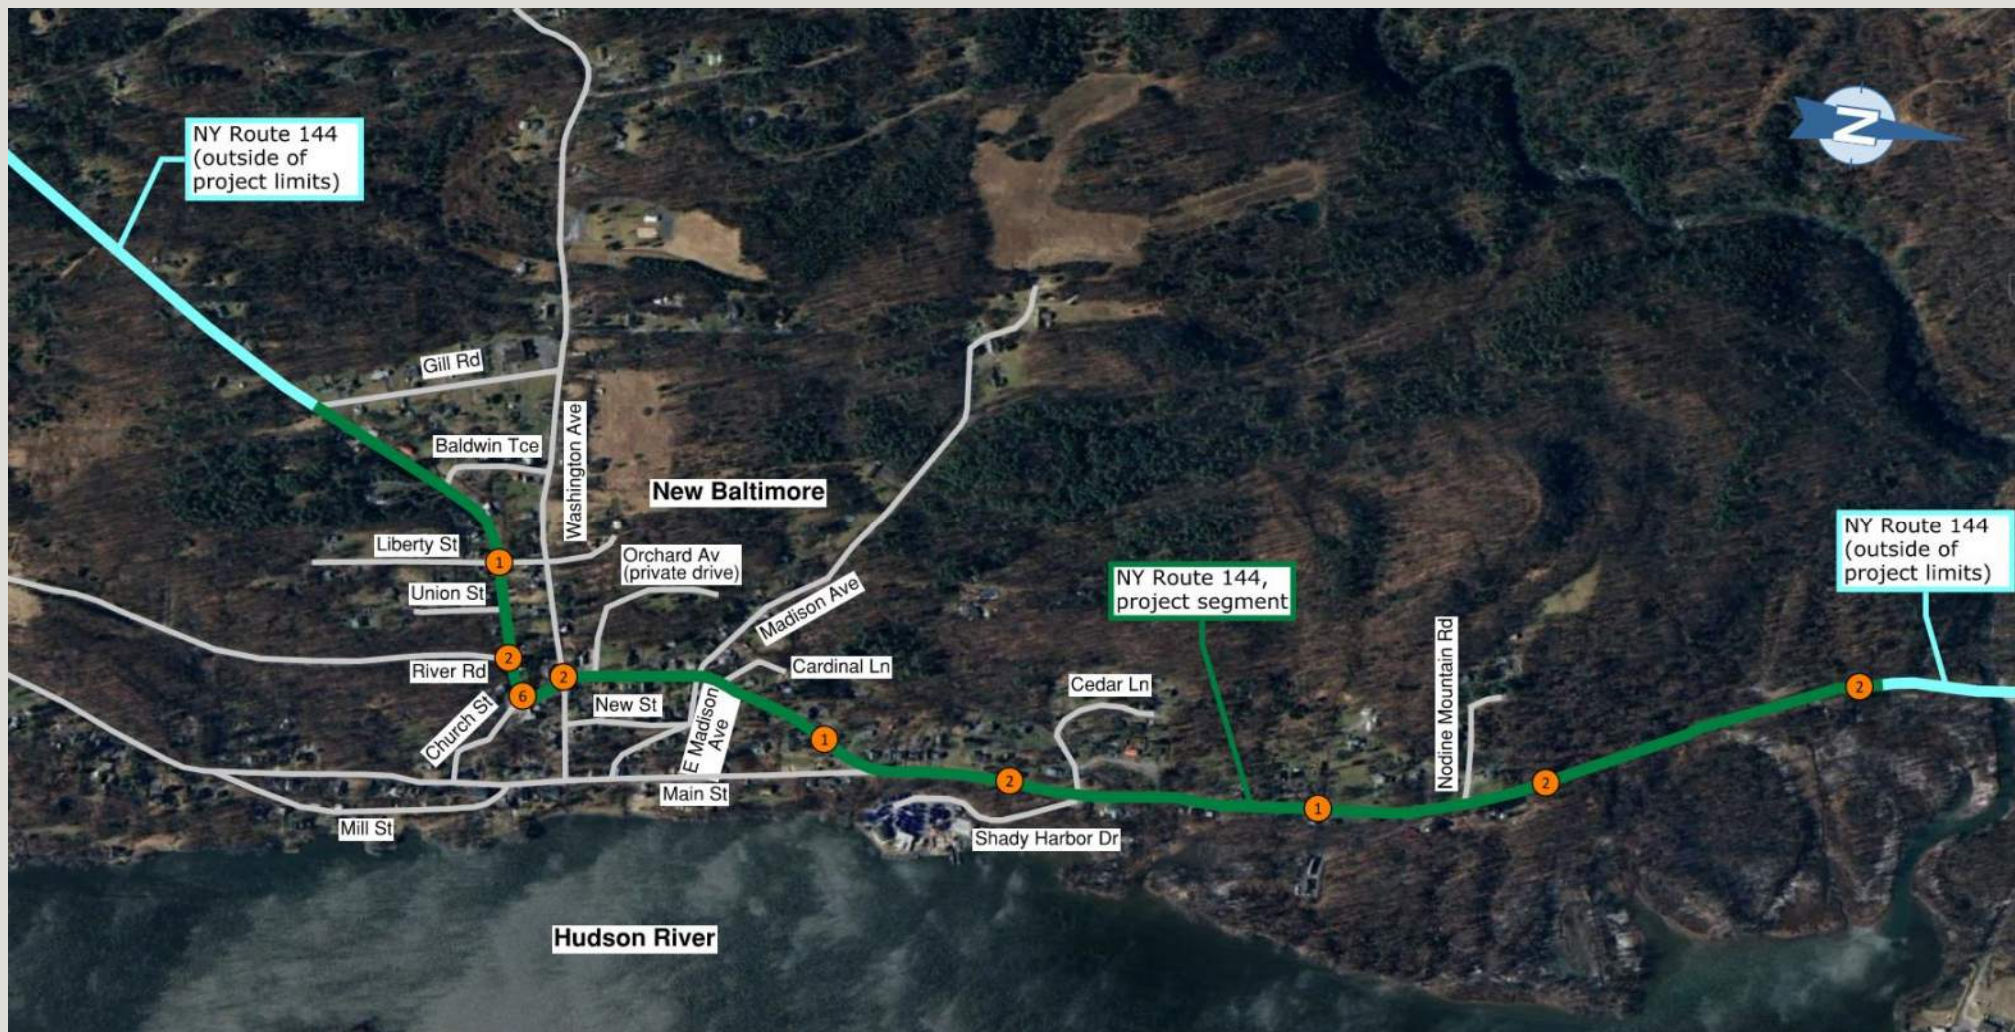
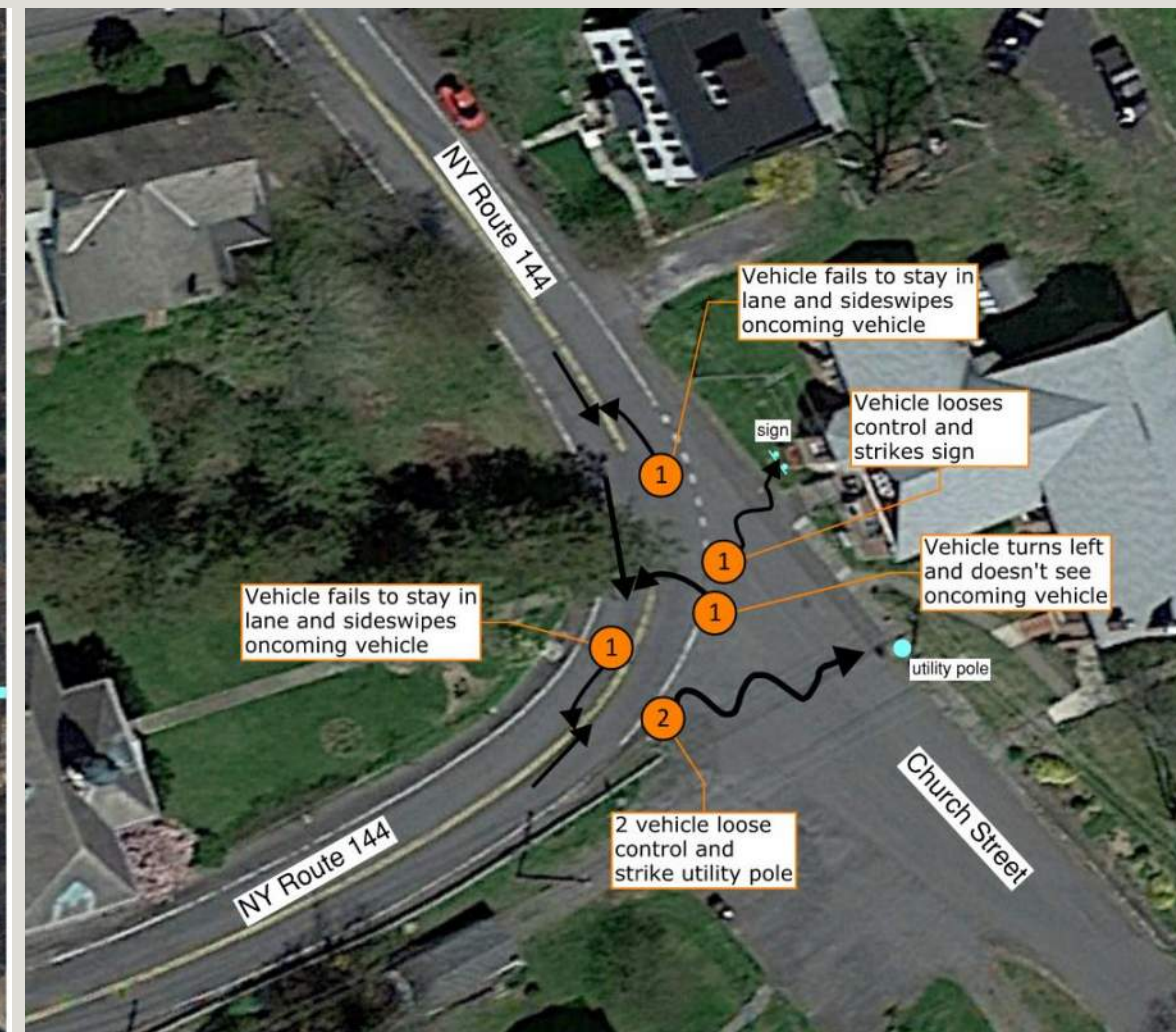
Crash Location History

- Includes the most recent five years of available data (December 31, 2018, to December 31, 2023)
- The data received was for the roadway and intersections along the NYS Route 144 Study Corridor.
- During this five-year period, 19 crashes were recorded. 11 of these crashes occurred at intersections.

Intersection Collision Location	
Intersecting Roadway	Quantity
River Road	2
Washington Avenue	2
Liberty Street	1
Church Street	6
Total	11

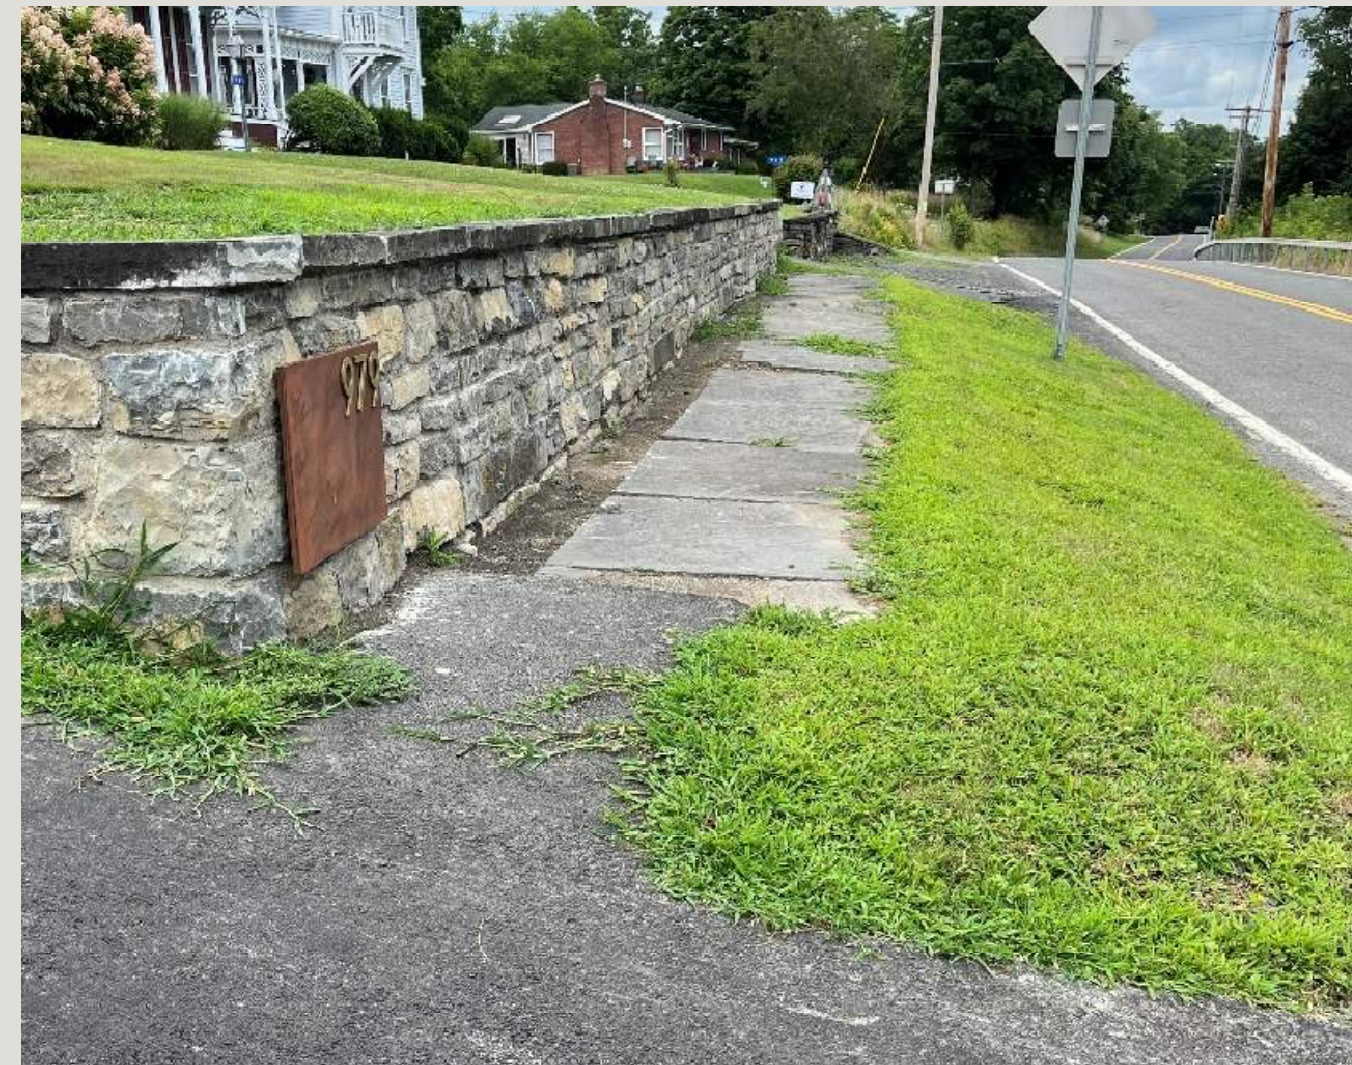
Pedestrian & Bicyclist Accommodations

Sidewalks and Crosswalks

- No concrete sidewalks are available anywhere along the length of NYS Route 144 in the Study Corridor
- There is one short (65 feet long) section of existing bluestone sidewalk in the Study Corridor. It is not ADA compliant.
- No striped pedestrian crosswalks are present

- In general, the Study Corridor has no pedestrian amenities, such as benches, trash receptacles, or pedestrian-level lighting

- No bicycle routes or accommodations are present

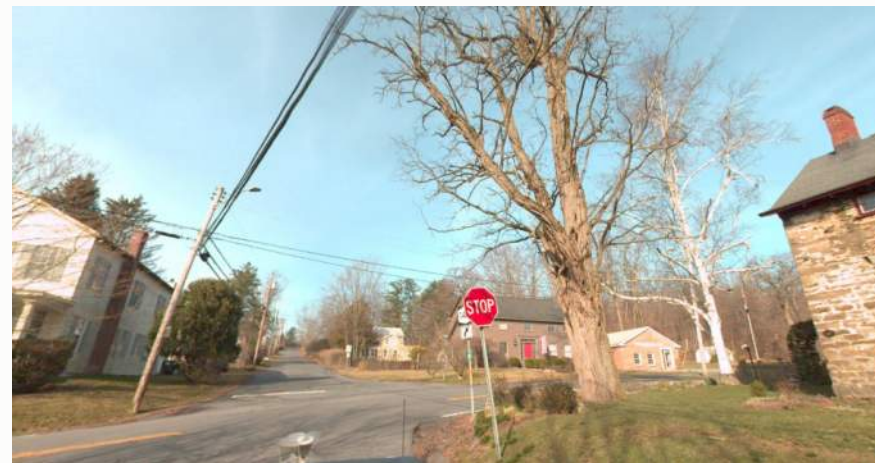
Limited Sight Distance

- Poor sight distance at Main St / NY 144 due to roadway geometry
- Poor sight distance at Washington Ave (east) / NY 144 due to the proximity of buildings to edge of pavement

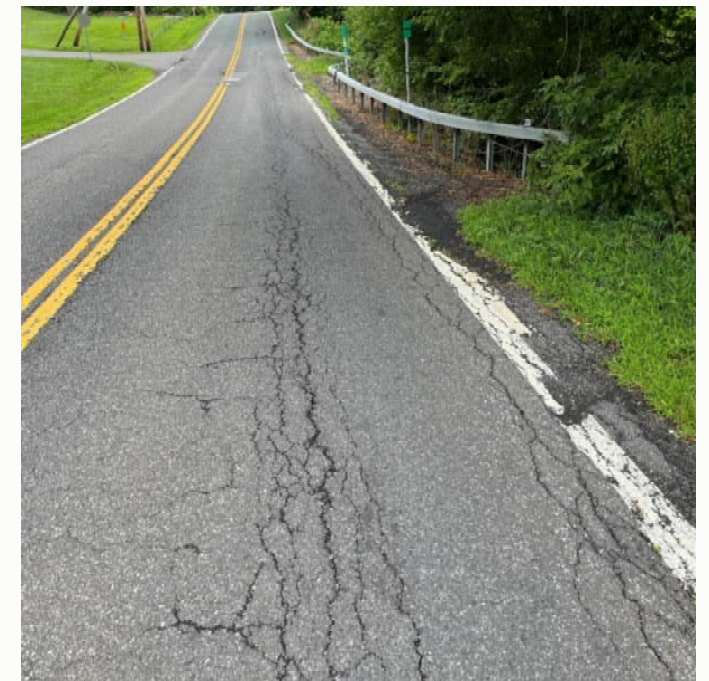
Pedestrian Infrastructure

- No sidewalks or marked crosswalks, limited signage
- No bicycle accommodations
- No amenities (benches, bike racks, etc.)

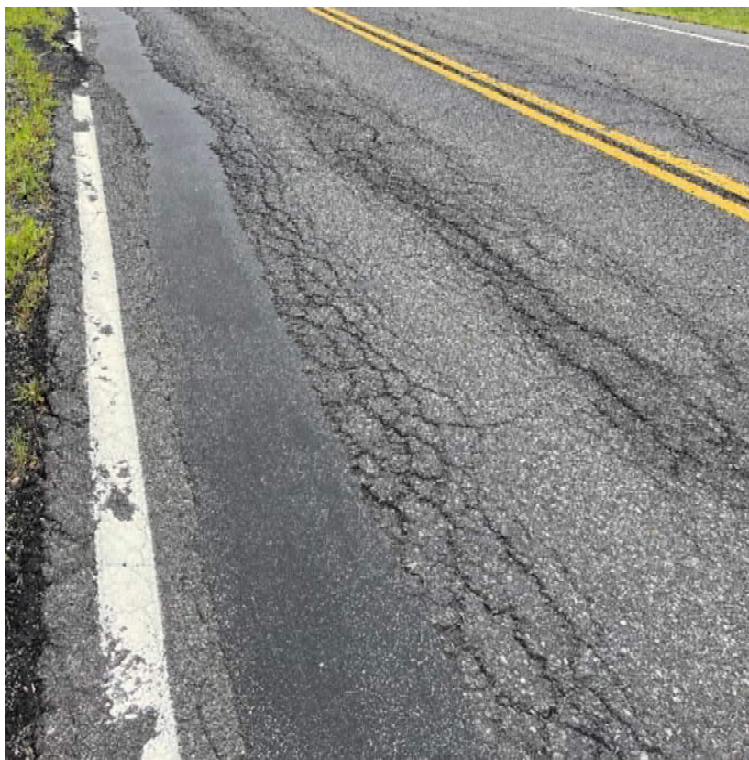
Deteriorating Pavement Conditions

- Pavement shows signs of wear, significant in some locations (i.e. Main St intersection)
- Pavement settling observed adjacent to steep slopes

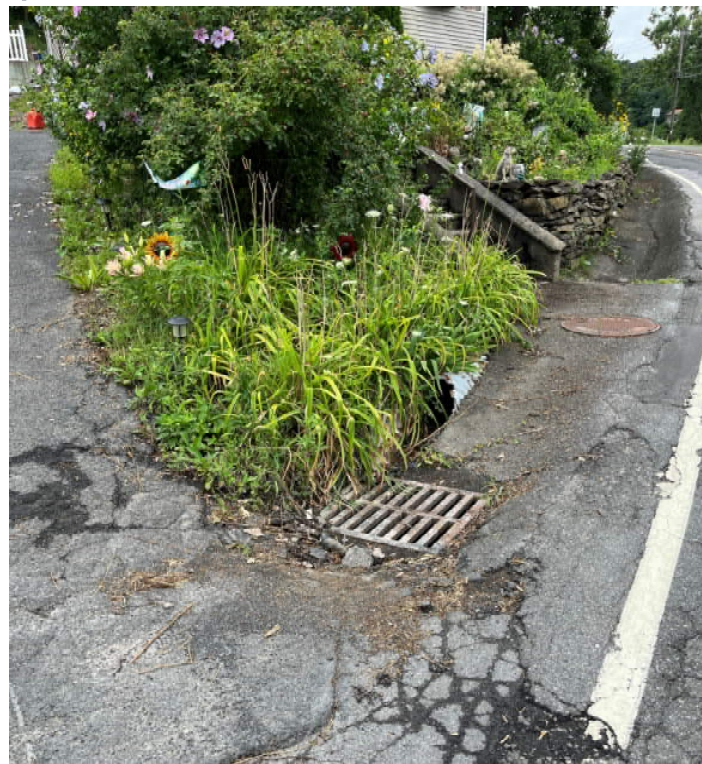
Drainage Conveyance

- No closed drainage between the northern study limits and the Washington Ave
- Roadside paved swales are unsafe for pedestrians
